**HAZARDOUS MATERIALS SURVEY  
ARTHUR ARENA & AQUATICS CENTRE  
156 & 158 Domville Street  
Arthur, Ontario**

**May 3<sup>rd</sup>, 2024**

Project No: L24-03848-14

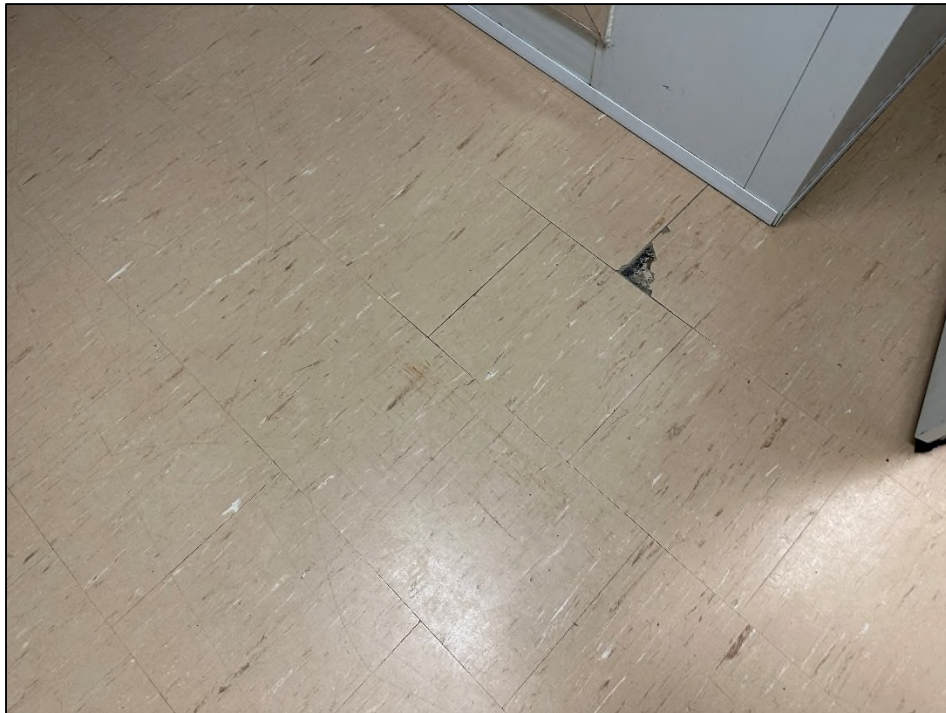
Asbestos-containing vinyl floor tiles are a non-friable material and were observed to be in good condition and assigned a Priority 2.

**Photograph 1:** View of asbestos-containing 12" beige vinyl floor tiles with white and black streaks (VFT-B) in the Bar/Freezer Room (Location 105), assigned a **Priority 2**.

Non-friable ACM assigned a Priority 1 must be removed and/or repaired immediately following applicable asbestos abatement procedures. Non-friable ACM assigned a Priority 2 can remain in place until major system upgrading, maintenance or demolition which could result in disturbance of this material. In the event the non-friable ACM is removed, Type 1 operations apply (provided that the material is wetted down and removed using non-powered handheld tools) as outlined in Ontario Regulation 278/05, *Designated Substance - Asbestos on Construction Projects and in Buildings and Repair Operations* – made under the Ontario Occupational Health and Safety Act.

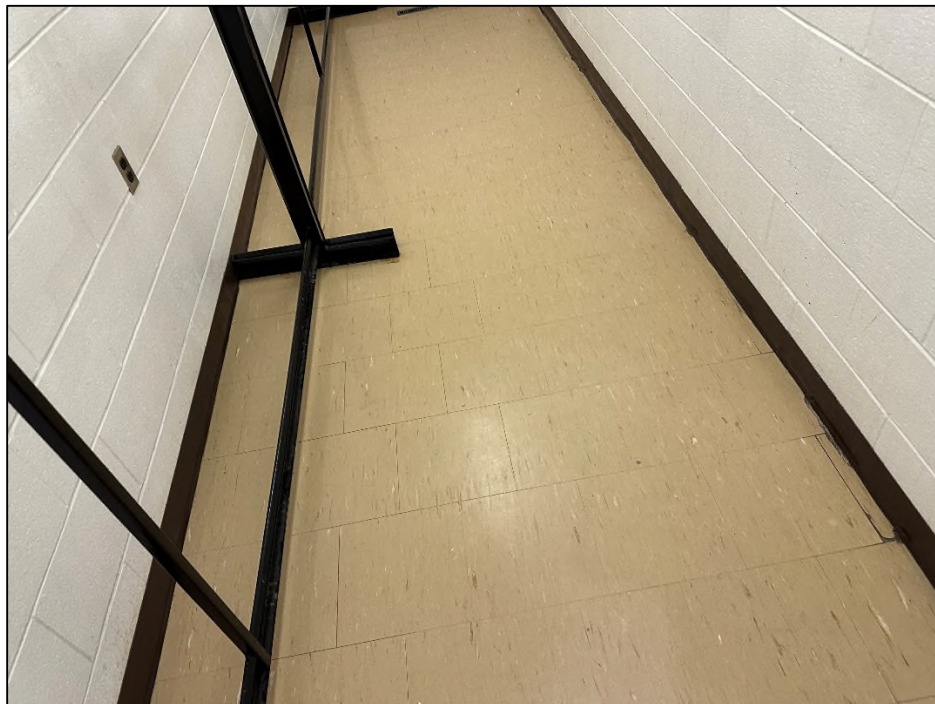
**Photograph 2:** View of asbestos-containing 12" beige vinyl floor tiles with white and black streaks (VFT-B) in the Coat Room (Location 107), assigned a **Priority 2**.

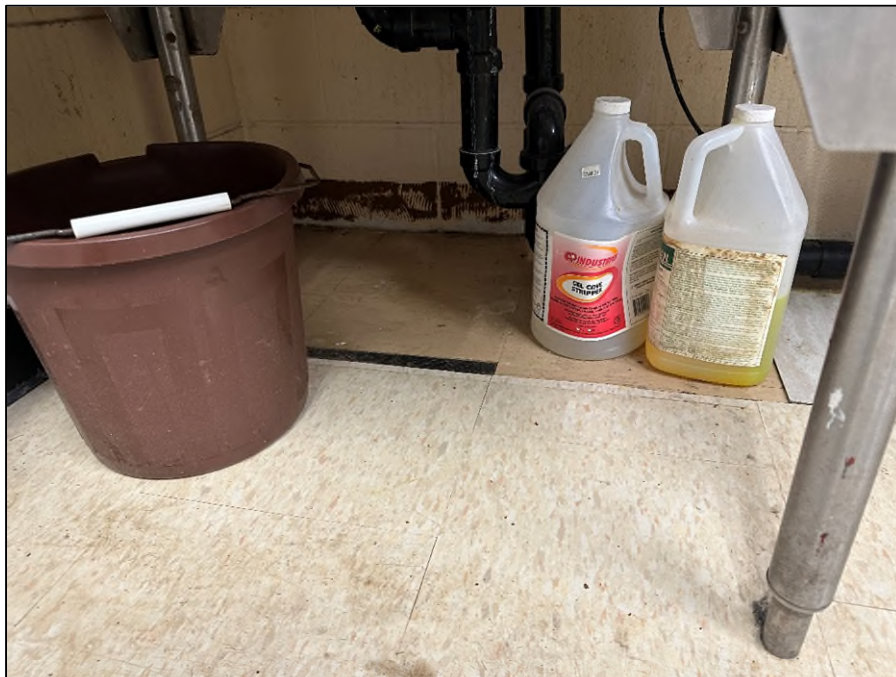
**Photograph 3:** View of six tiles of asbestos-containing 12" beige vinyl floor tiles with white and black streaks (VFT-B) under the sink in the Concession Stank (Location 123), assigned a **Priority 2**.
